## *Reflections on a cold plunge*

*A personal view of one of the most interesting features of Barcombe's Roman bathhouse*

*by David Millum AlFA MA*

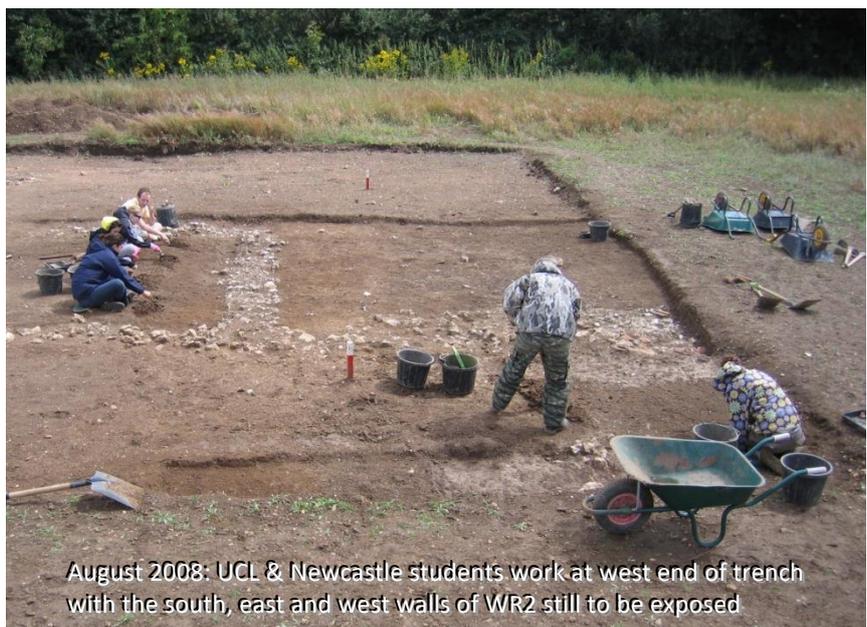
August 2008: UCL & Newcastle students work at west end of trench with the south, east and west walls of WR2 still to be exposed

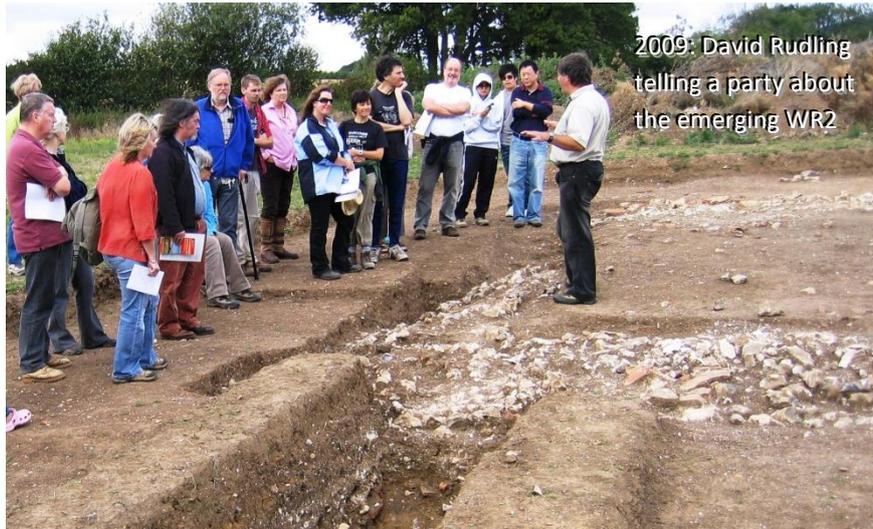
2009: David Rudling telling a party about the emerging WR2

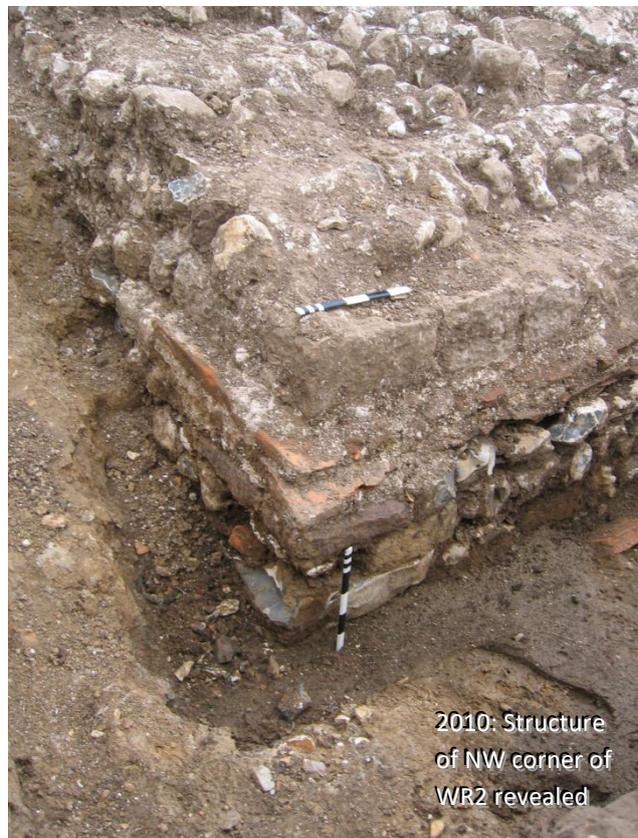
2010: Structure of NW corner of WR2 revealed

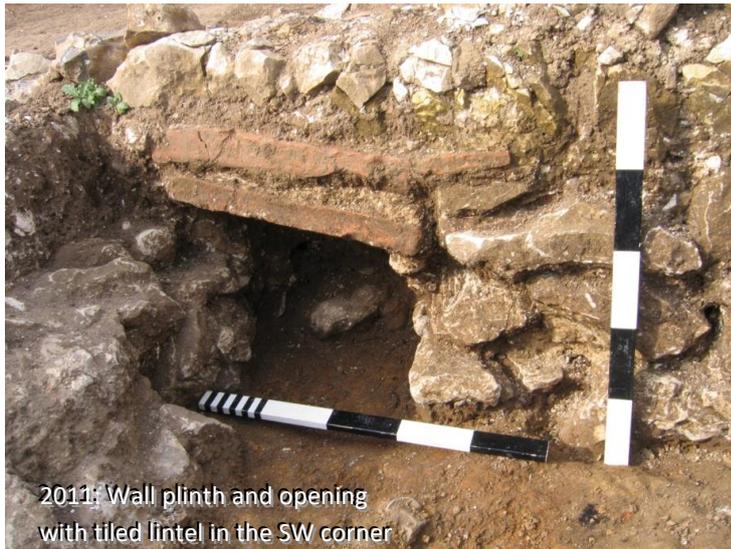
2011: Wall plinth and opening with tiled lintel in the SW corner

square conduit [context 3360] at the base of the extreme SW corner under a two course tile lintel. Was this a drain outlet or water inlet for a bath or thermal inlet for a heated room, or did the plinths imply a suspended floor with the partition wall merely a sleeper for bearing joists and the conduit a drain to keep the underfloor area dry? It seemed that however much we excavated this feature we always ended up with more questions than answers.

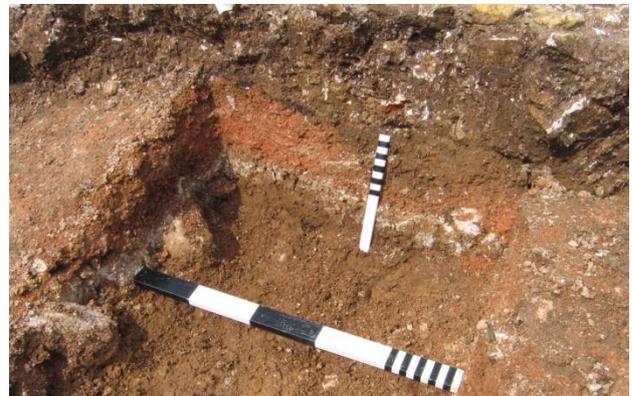
The north east quadrant was proving equally enigmatic. The black sooty sand (3230) to the north edge gave way to a pinkish fill (3376) which was possibly the remains of an *opus signinum* floor as it began to appear to be more than just a tumbled layer of crushed tile and mortar and had a distinct layer of compacted chalk (3380) beneath it. By week 3 these two quadrants were sufficiently excavated for Steffan Klemenic (our assistant site supervisor in 2012) to draw the four faces that gave us a complete cross section in both directions. The other 2 quadrants were then taken down but a baulk was left beside the partition wall so that its stratigraphy could be compared with that of the wall section when subsequently excavated. When the western half of the wall was removed there appeared to be some distinct differences between the fills on either side with significantly no repetition of the thick *opus signinum* layer in the southern area.

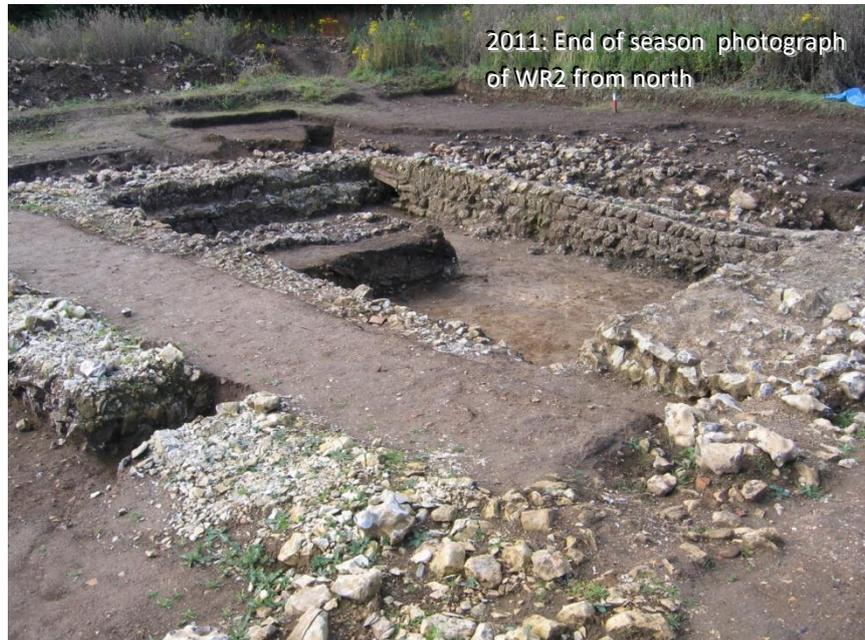
By the end of the 2011 season the interior of WR2 was fully excavated but there was no evidence that the structure had been capable of holding water however with so much of the best building material obviously robbed from the building, possibly still within the Romano British period, the lack of evidence could certainly not be taken as proof that we were not seeing the remains of a cold plunge pool.

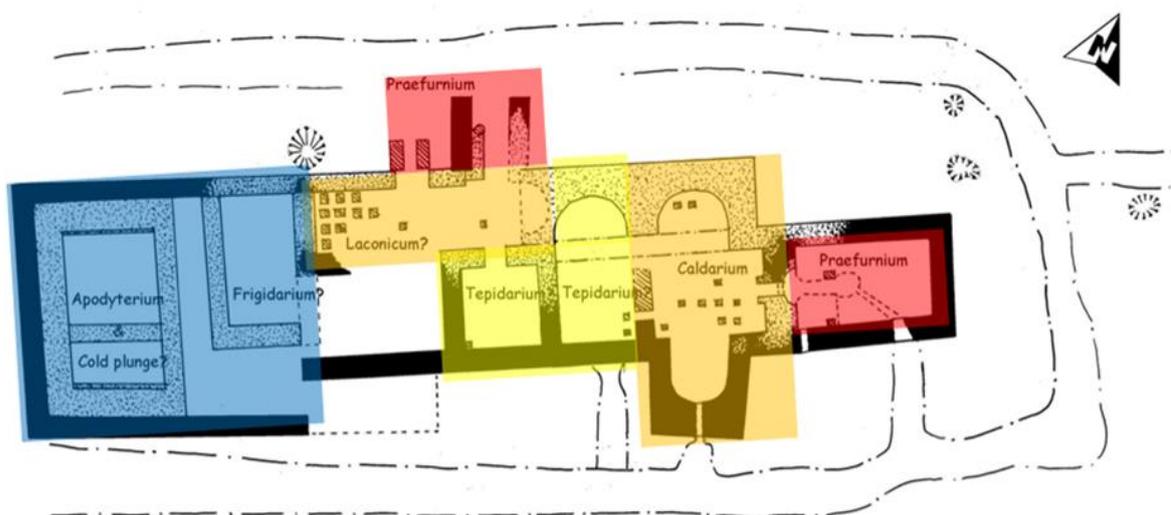
For a presentation to the Lewes Archaeological Group I produced a diagram showing the probable temperature zoning for the bathhouse if considered as one building. This placed WR2 at the extreme cold end of the complex and therefore an ideal location for a cold wet use such as a plunge bath. It should be noted however that there may be quite a presumption in seeing the whole building in use at one time rather than in several phases.

KEY cold areas : blue warm areas : yellow hot areas : orange furnace areas : red

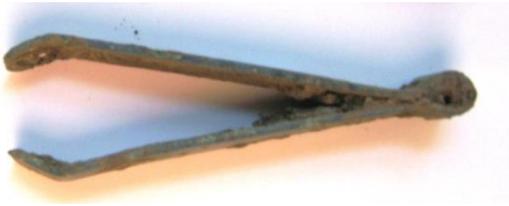
ear wax spatula (right) from within the drain. In 2011 a pair of cooper alloy tweezers (left) in remarkable condition had been found just outside WR2's southern wall and these often form part of a toilet set which also includes an ear wax tool.

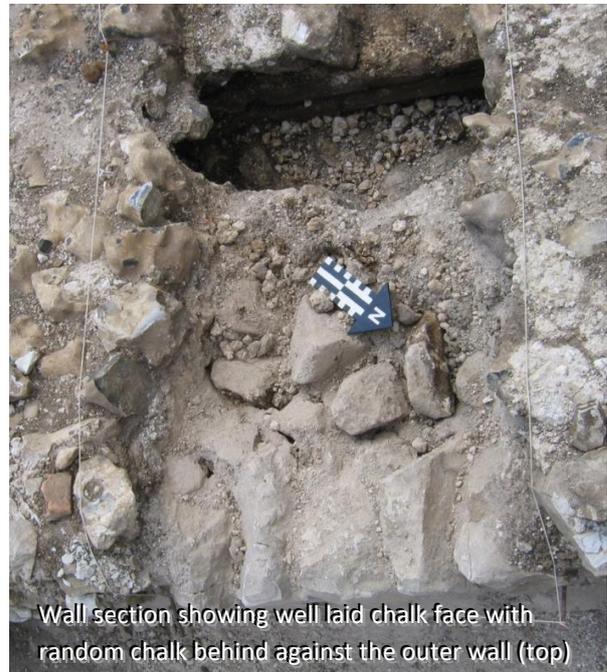
Wall section showing well laid chalk face with random chalk behind against the outer wall (top)

on the western end of the south wall could well have played a part in the collapsed nature of the flint section of the west wall with the infilling of the interior of the room helping to preserve the chalk facade. The considerable flooding that occurred during the summer of 2012 pointed to the potential for the washing out of the lime mortar from the flints, a material with which mortar cannot form a permanent bond.

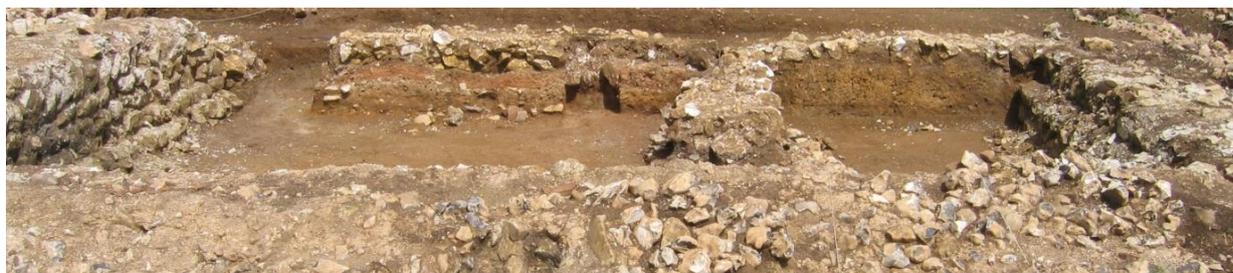
August 2012: WR2 from the west showing the *opus signinum* floor layer in the northern area but absent to the smaller southern section.

A section through the east wall showed that the *opus signinum* layer did not go beneath the wall suggesting that it was laid subsequent to the construction of this wall as well as abutting the deeper outer walls, supporting an interpretation of the east wall as part of the original structure.

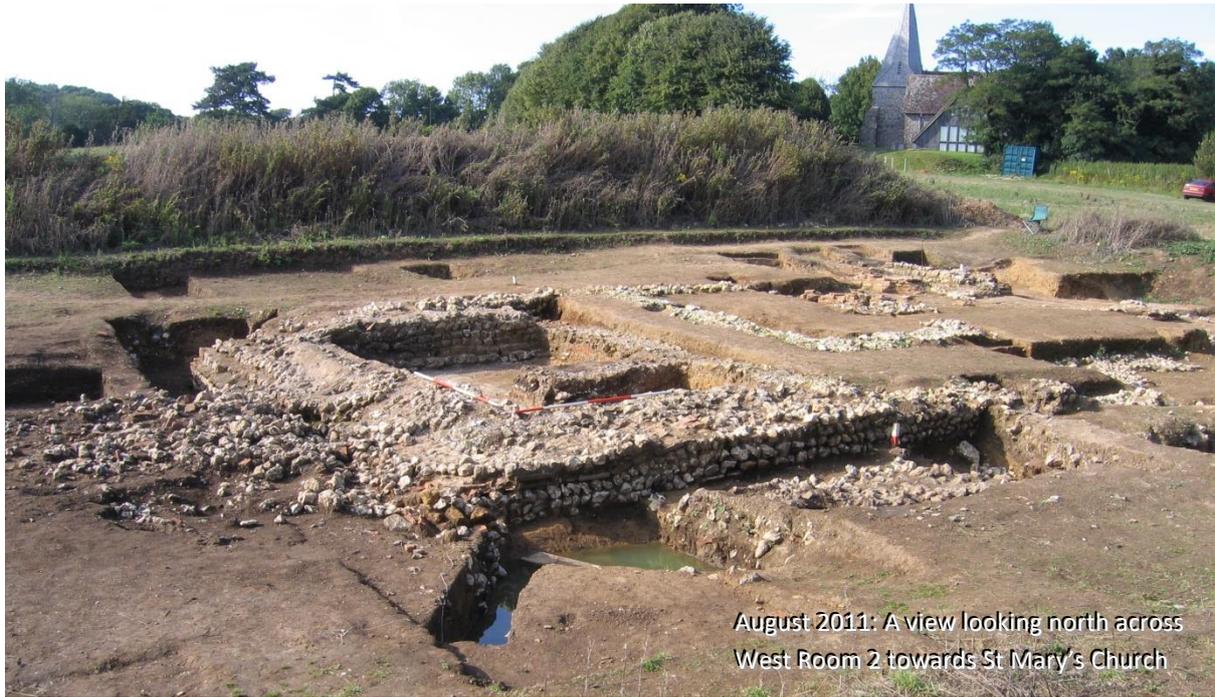
I see no obvious reason not to suggest that WR2 was the cold plunge facility of the *balneae* complex. I also suggest that the room probably provided a substantial changing and drying area, *apodyterium*, in the northern section with the plunge pool occupying the entire southern area beyond the partition wall. Any material used to line this pool could have offered valuable resource removed for reuse when this area of the bathhouse was decommissioned.
